TESTING OF HIGH PRESSURE HYDROGEN COMPOSITE TANKS

**Ben C. Odegard, Jr. and George J. Thomas
Sandia National Laboratories
Livermore, California, USA**

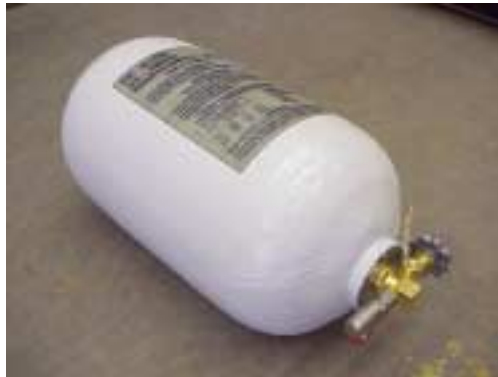
Figure 1. Photograph showing general features of the tests cylinders.

State-of-the-art composite vessels were manufactured by a commercial vendor for these tests. They were purchased commercially through a competitive bidding process and certified for use at 34.5 MPa (5000 psi) hydrogen. The polymeric-lined, graphite/glass-reinforced epoxy vessels (Type IV) were tested by the manufacturer to 96 MPa without visible damage. The internal volume is 24 liters with an outside diameter of 23 cm and a total outside length of 35 cm. When filled to 34.5 MPa, they have a storage density of 5-wt.% hydrogen. These vessels are compatible for both hydrogen and natural gas containment. A photograph of the general features of the cylinder is shown in Figure 1. Vessel features include a steel (4340 HSLA) single collar with an attached valve. An integrated pressure relief device is generally used, but was not included for these tests. A small number of similarly constructed vessels (Type IV) were purchased from another vendor. However, the modified test matrix did not include these vessels.

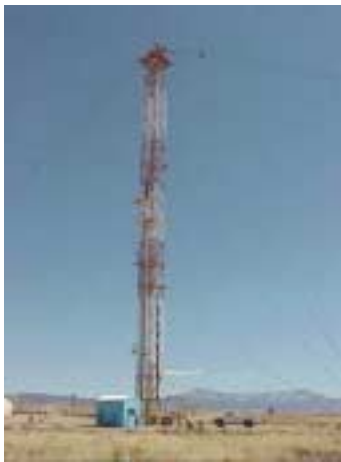
Figure 3a showing drop tower used for nitrogen tests (Tests 1-9)

Only penetration tests were made in the modified test matrix and two different test sites were used. In Phase I, tests were conducted at a drop tower facility which allowed better video diagnostic capability. However, a large cylindrical shield was employed to protect adjacent buildings and personnel from the potential debris. All Phase I tests were made on tanks filled with nitrogen. In Phase II, a remote facility was used to allow measurements on the hydrogen plume ignition. Overall views of the sites are shown in Figure 3a and 3b. A continuous spark igniter system was used to assure ignition during the hydrogen tests. This simply consisted of a high-performance vehicular spark plug transformer supplying high voltage to spark plug wires positioned at the edge of the expected release plume. More details are given later in this report.

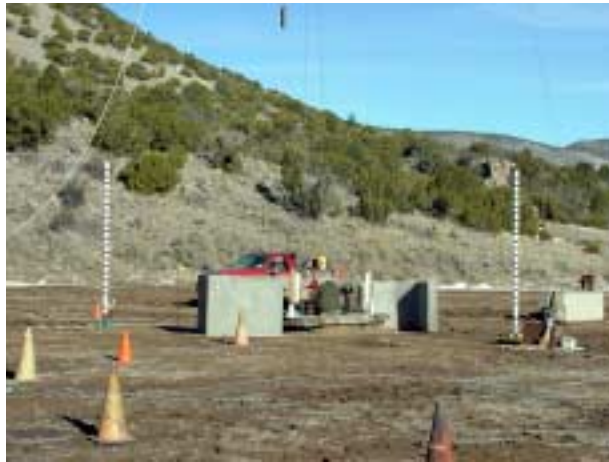
Figure 3b showing remote cable site used for the hydrogen tests (Tests 10-14)

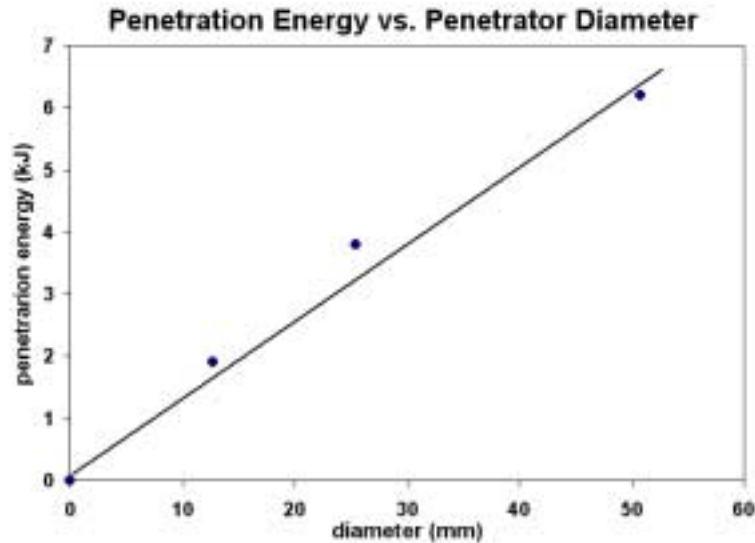
Figure 4. A plot of the measured penetration energy as a function of rod diameter.

Additional tests were then conducted with different diameter rods and the penetration energy determined as a function of rod diameter. These results are plotted in Figure 4. One can see that the energy is a linear function of diameter that suggests shear strength dependence as shown in the following equation:

Where τ is the shear strength of the composite, d is the diameter of the rod, t is the shell thickness and δx is the distance required to shear the lay-up. Thus, the effective shear area is defined by the circumference of the penetrating rod and the wall thickness over which the rod acts. Examination of the tank penetration shows a cylindrical hole of nearly the same diameter as the rod that is consistent with the above interpretation. Further, high-speed video observations during one of the tests showed an intact disc of the tank shell being ejected from the penetrated region, nearly the same diameter as the rod, again, consistent with the above interpretation.

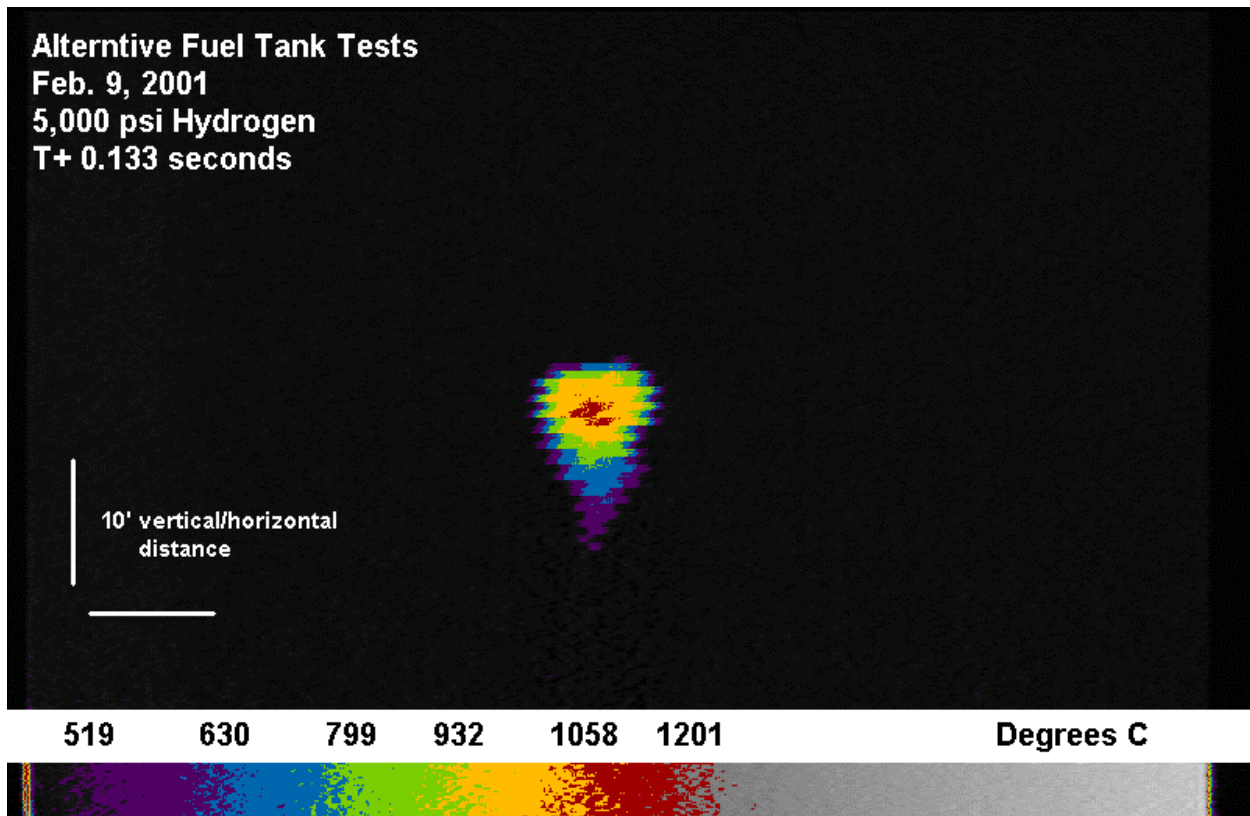
Figure 5. A false color infrared image of an ignited gas plume 133 ms after puncture and ignition of the hydrogen-filled vessel. This image shows the maximum temperature reached during the event. The color bar at the bottom gives the corresponding temperatures and colors.

Figure 5 shows a false color infrared image of the ignited gas plume 133 ms after puncture and ignition during Test 10. In this test, the tank was filled with hydrogen to 34.5 MPa and a 12.7 mm diameter rod was used. The hole in the outer composite wrap was measured after the test and found to be about 25% larger than the rod diameter. The color variation in the figure corresponds to temperature gradients (as indicated on the color bar at the bottom of the figure). This image is one of a series of images that show the evolution of the gas plume with time and was chosen to show the maximum temperature reached during the test. The peak temperature of about 1100°C was reached when the ignition center had risen to almost 6 meters above the test platform. Note that the plume has expanded to almost 3 meters width at this height, consistent with a half angle of 15° assumed in placing the igniters. After 300 ms, the maximum temperature in the plume had dropped to about 800°C. This example was typical of all of the tests and shows that the very high buoyancy of hydrogen rapidly elevates the flame front away from the surrounding area. These results are consistent with those of Swain et. al. ^{5, 6, 7, 8}, in which a continuous gas source was used to form an ignited hydrogen plume. The present results show that with rapid depressurization of a punctured tank, the gas plume both decreases and rises with time. More extensive IR images are shown in the final report of this project to be published.

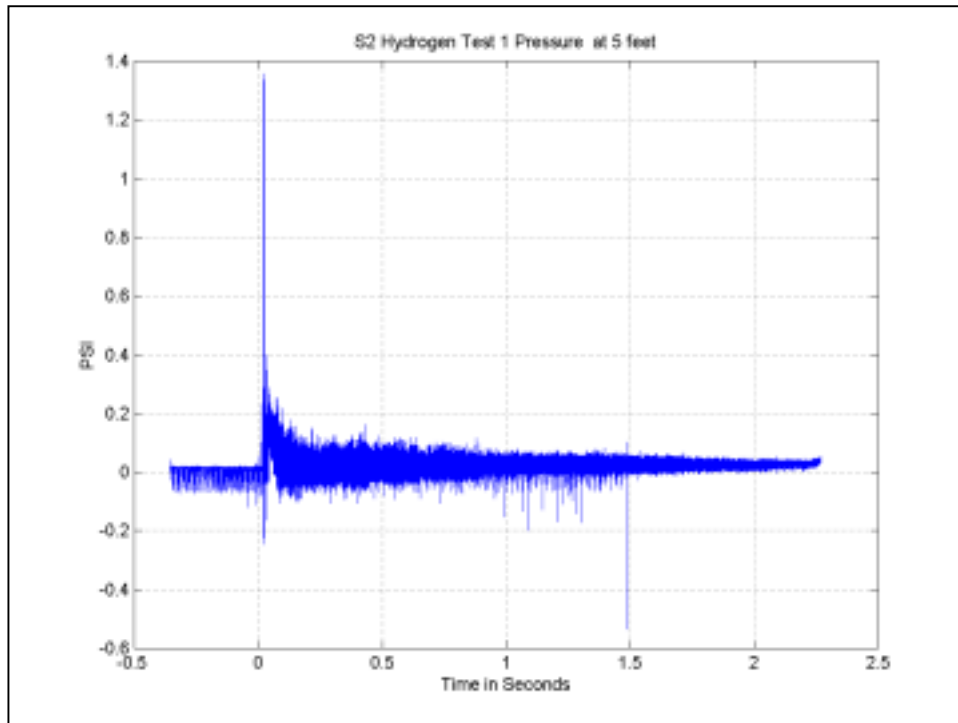
Figure 6. A plot of the overpressure induced by ignition of the venting gas during Test 10 at a distance of 1.5 meters from the tank.

The transducers were approximately 1 meter off the ground. Figure 6 is a plot of a transducer output approximately 1.5 meters from the ignition source during Test 10 (12.7 mm rod, 34.5 MPa fill pressure). The peak pressure of 0.01 MPa (1.4 psi) above ambient was of very short duration and coincided with ignition of the gas. There is a slight under-pressure developed about 100 ms later that is expected from a pressure wave where the high pressure pulse sweeps air away from the immediate region of the event. At 3 meters from the point of ignition, the peak pulse pressure was only 0.001 MPa (0.14 psi), consistent with a spherical ($1/r^2$) drop-off in pressure with distance. Overall, this is a relatively modest pulse that, we believe, would not lead to serious injuries or damage. As discussed in the next section, Test 10 produced a clean venting of the gas and a relatively large hole for the gas to be vented. We believe that this size of hole, which is larger than typical tubing diameters used in plumbing high pressure tanks, is a reasonable maximum credible failure for a tank of this design. Hence, the present results suggest that the risks associated with storing high-pressure hydrogen are no greater, and perhaps less than, other fuels, such as gasoline or propane.
